**Subject:** Global Alternative Method of Compliance (AMOC) to Airworthiness Directive (AD) 2011-07-13 paragraph (g) “inspection and repairs” – Proposing a different method of inspection to inspect the outboard elevator hinge brackets and the elevator spar behind the bracket for cracks

**Reference:** (1) AD 2011-07-13 – on CPAC Inc Commander Models 112, 112B, 112TC, 114, 114A, 114B, and 114TC  
(2) Commander Owners Group (COG) email dated April 18, 2011 requesting an AMOC to AD 2011-07-13 paragraph (g)-proposing an alternate method for inspection.

### Alternative Inspection Procedure for AD 2011-07-13

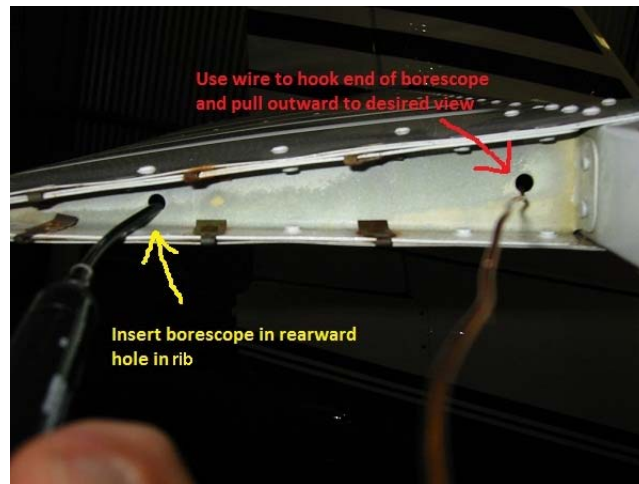
- g. If the DPI finds any cracks or cracks are suspected, proceed to Step 4.
3. Inspect the aft face of the spar web in the area of the fitting with a flexible fiberscope/borescope which should have the following characteristics: resolution of at least 720x480 for video or 10,000 fibers for direct visual use, 6mm or smaller shaft size, focus down to 4cm, and 10x magnification. The inspection procedure varies slightly depending upon the Commander model as two different end ribs were used in production.
- a. **Full length rib used in most early models.** Insert borescope in the rear lightening hole on the outer elevator rib (see picture below). Inspection should cover the areas surrounding the four attachment nuts and extending upward and downward to the elevator skins and at least 1" inboard and outboard from the nuts. If suspect areas are noted, proceed to Step 4.

If no suspect areas are noted, this completes the inspection. Proceed to Step 5 to report results.

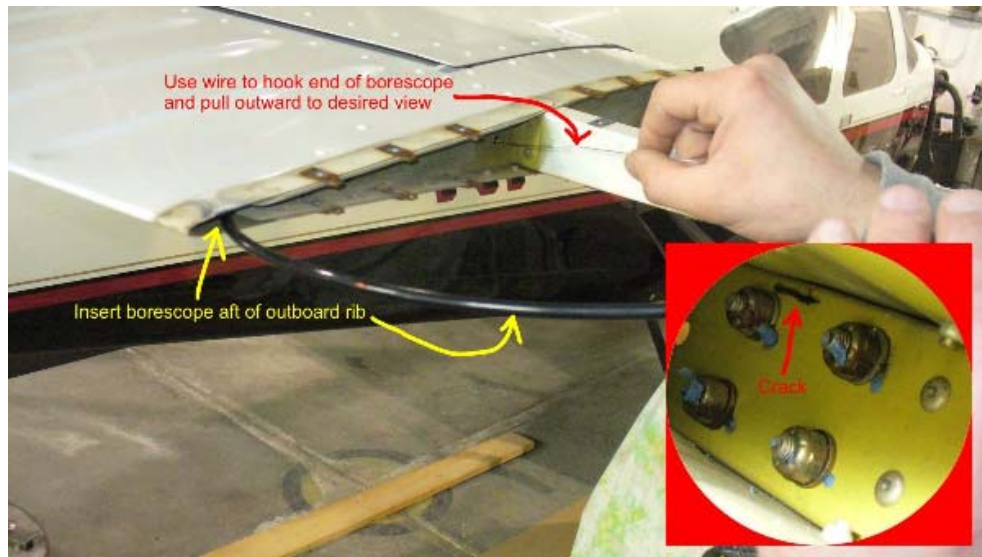
- b. **Shortened rib used in most later models.** Insert the borescope between the aft end of the outboard elevator rib and the trailing edge of the elevator skin (see picture below).

Inspection should cover the areas surrounding the four attachment nuts and extending upward and downward to the elevator skins and at least 1" inboard and outboard from the nuts. If suspect areas are noted, proceed to Step 4.

If no suspect areas are noted, this completes the inspection. Proceed to Step 5 to report results.
