DER is preparing a report to provide basis for the following:

Rib Installation - Riveting Procedure

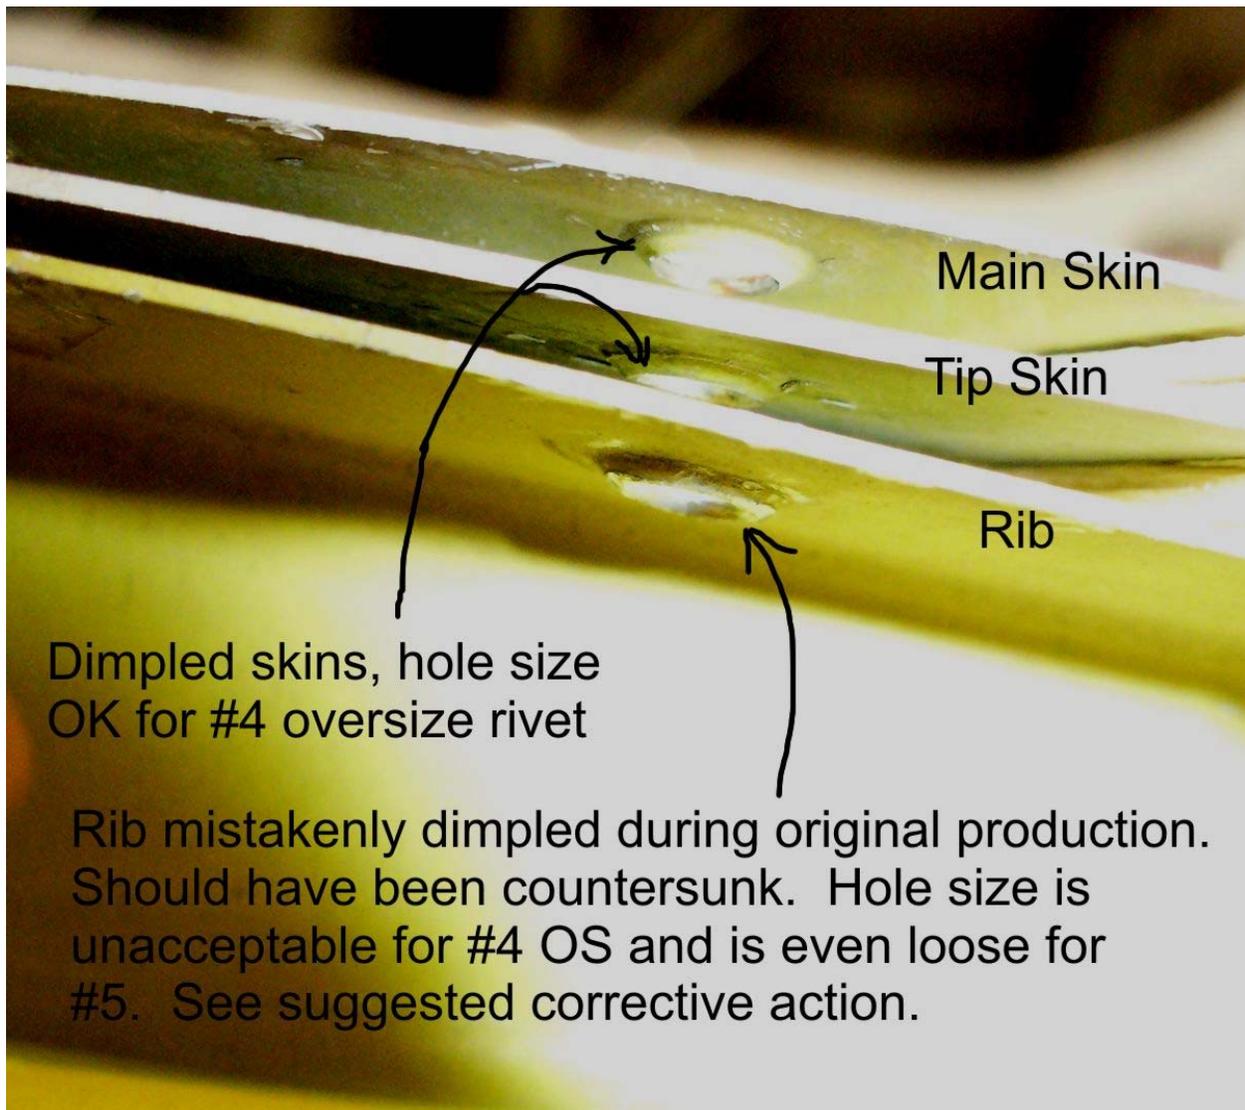
Some, maybe most, of the ribs were not properly originally installed. The assembly procedures called for the two skins to be dimpled, but the ribs to be countersunk. In fact, it appears some ribs were dimpled along with the skins causing the rivet hole in the rib to be already very loose for even a #5 rivet while the skins are probably still good for a #4 oversize, see picture.

Based on field reports, it seems that 112 s/n's 1 thru 125 were built correctly.
